Parametric Studies on Structural Behaviour of Retrofitted R C Beams Using GFRP

Abstract - Fiber Reinforced Polymer (FRP) has been established as an effective retrofit material world wide. Several researches have been carried out to evaluate its behaviour as retrofit material on different structural components with varying configuration. In the present work, the use of FRP for retrofitting of structural elements was reviewed with special emphasis on reinforced concrete (RC) beams. An experimental study was carried out on twenty seven RC beams. The beams were strengthened with single, double and triple layers of externally bonded Glass Fiber Reinforced Polymer (GFRP) of varying fiber content measured in grams / square meter (GSM). The RC beams were tested up to failure using a four point static loading system. The efforts have been taken to investigate the effect of different amount and configuration of GFRP wrapping on ultimate load capacity, central deflection and failure modes of the beams.

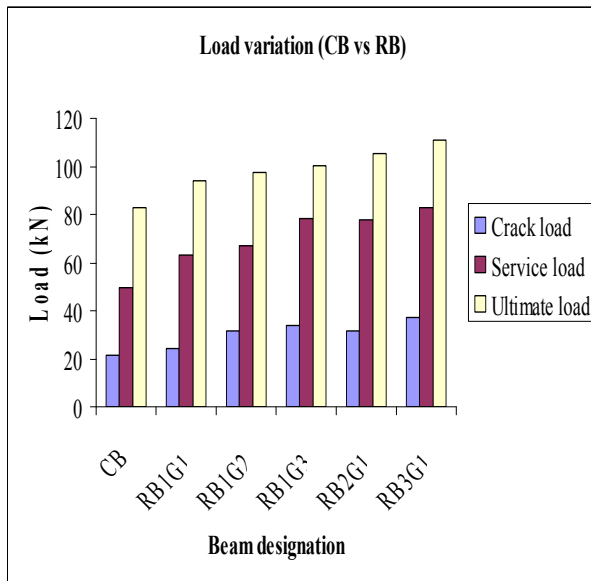
Fig. 3: Load variation for CB and RB specimens

Single layer with 600 GSM: The corresponding values of load and central deflection for VB and RB specimens at first crack load were 39.95 kN (0.73 mm), 24.33 kN (0.49 mm); at service load were 52.25 kN (1.85 mm), 63.37 kN (1.85 mm); at ultimate load were 96.85 kN (6.77 mm), 94.13 kN (4.98 mm) respectively.

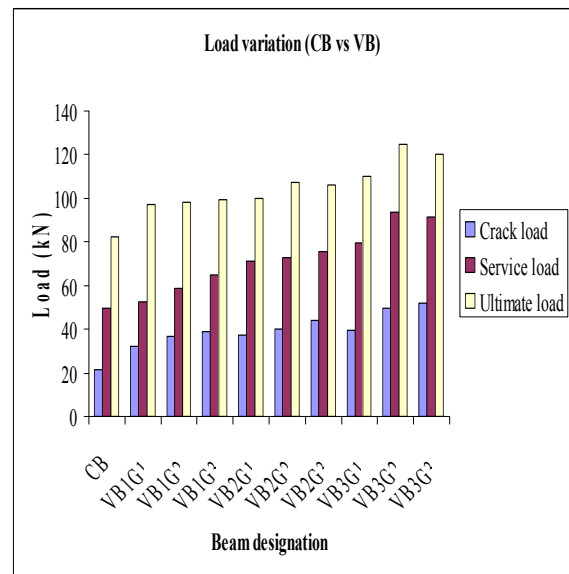
Fig. 4: Load variation for CB and VB specimens

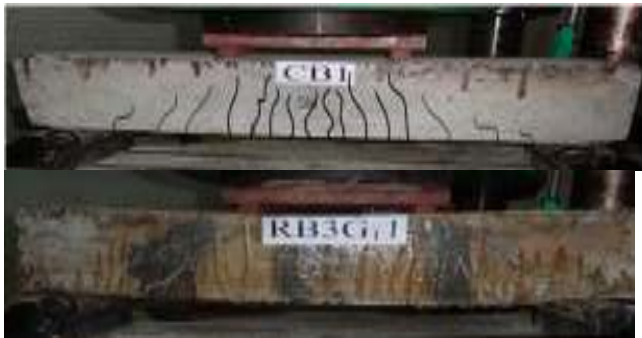
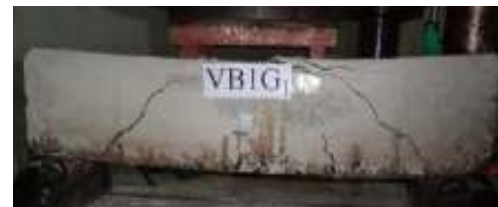
Fig. 5 – Failure patterns for beams

The control beams exhibited flexure failure with major vertical cracks at mid span with appearance of shear cracks at the failure stage. For control beams, crushing of concrete was not observed. From all the other GFRP wrapped beams none of the beam showed the flexure failure. The beams failed with shear cracks propagating and leading to debonding of laminate just below the crack. The debonding was observed to propagate towards end supports. Certain specimen showed full end debonding of laminates beyond supports. The roller supports acted as anchoring system and prevented end debonding from propagating towards mid span. The failure patterns for control beam, repaired beam and virgin beams are shown in **Fig. 5**.

3. None of the beams except control beams showed flexure failure i.e. the beams showed increased strength in flexure. The failure pattern for strengthened beams was noticed in shear failure of the section along with delamination of GFRP below the crack towards support.
