## **A Case Study of Defects Reduction in a Valve Guides of cylinder heads for large engines Manufacturing Process by Applying Six Sigma Principles and DMAIC Problem Solving Methodology**

V S Biraris<sup>1</sup>, Dr. E R Deore<sup>2</sup>

<sup>1,2</sup>Mechanical Engineering Department, S S V P S Bapusaheb Shivajirao Deore College of Engineering, Dhule

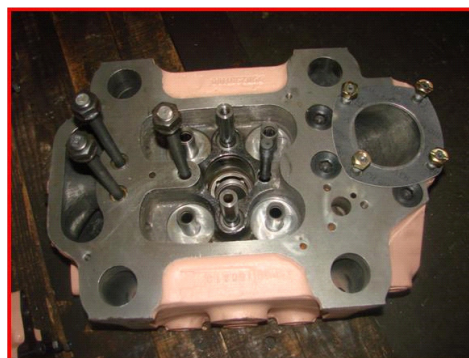
**Fig.3 Valve Guide fitted into Cylinder Head**

- a) Finished Valve guides from stores (from Supplier) & Finished Cylinder head from Machine shop.
- b) Snap Ring fitment on the valve guide groove (At Sub-Assembly)
- c) Valve guide Dipping into liquid nitrogen (At Sub-Assembly)
- d) Valve guide fitment into Cylinder head (At Sub-Assembly)

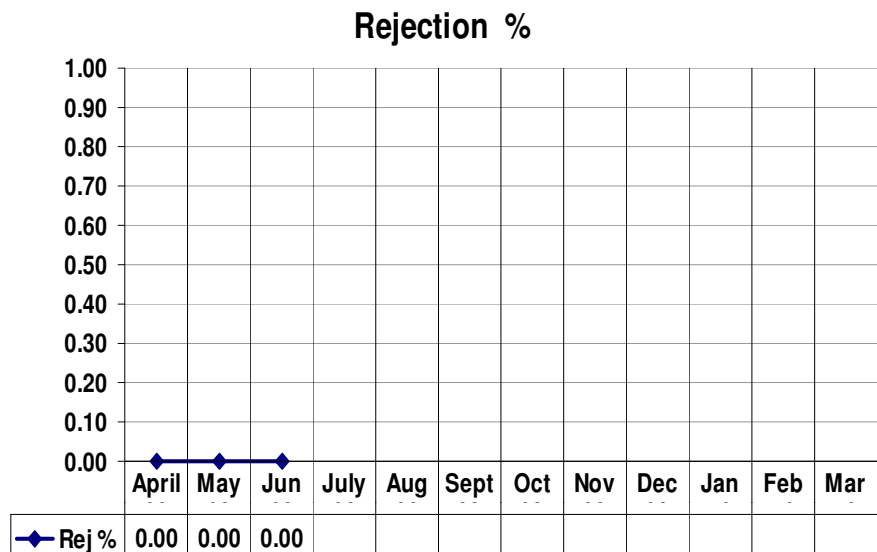
Fig. 5 Rejection Trend in Year 2014 to 2015

Monthly rejection trend after  
 April 14 to Mar 15

1. Valve Guide Overall scrap reduced from 38500 PPM to 0 PPM.
2. Valve Guide ID undersize scrap reduced from 38500 PPM to 0 PPM.
3. Estimated cost benefits is Rs. 0.28277 Lakhs per year.
